(NASA-CR-193902) FINAL POSTFLIGHT
HARDWARE EVALUATION REPORT RSRM-28
(STS-53) Final Report (Thiokol
Corp.) 285 p

TWR-64216

Final Postflight Hardware Evaluation Report RSRM-28 (STS-53)

November 1993

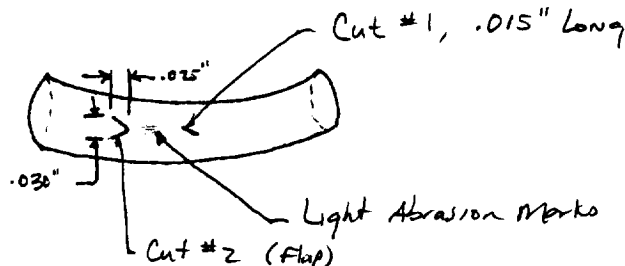
Two anomalous conditions were observed. Two cuts were seen on the LH 126-degree barrier-booster leak check plug O-ring OD. The first cut measured 0.015 inch long and did not leave a flap of material. The second cut left a flap of material and measured 0.025 inch circumferentially and 0.030 inch axially. (See Preliminary PFAR 53C-09.) One cut was observed on the RH 126-degree barrier-booster leak check plug O-ring OD. The cut measured 0.005 inch circumferentially and 0.010 inch axially. (See Preliminary PFAR 53C-10.)

#1.) Two cuts observed on O-ring O.D. See sketch below for approximate measurements and clarifications.

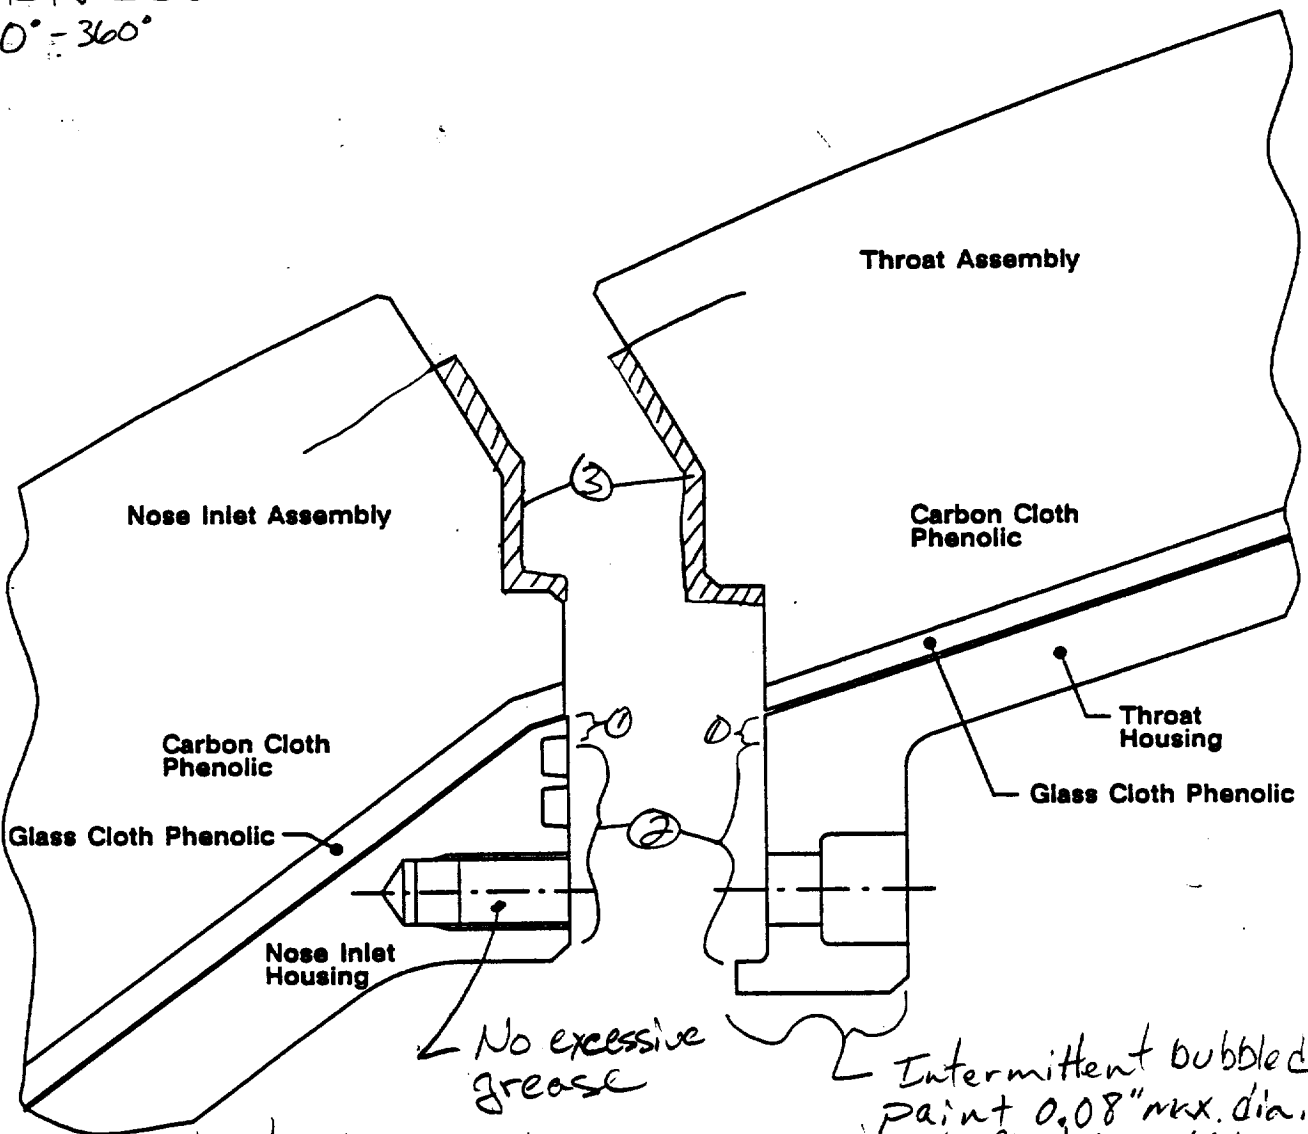
3) RTV below the char line
0° - 360°

1) Intermittent light-to-medium corrosion around the circ.

2) Nominal grease coverage with no corrosion.

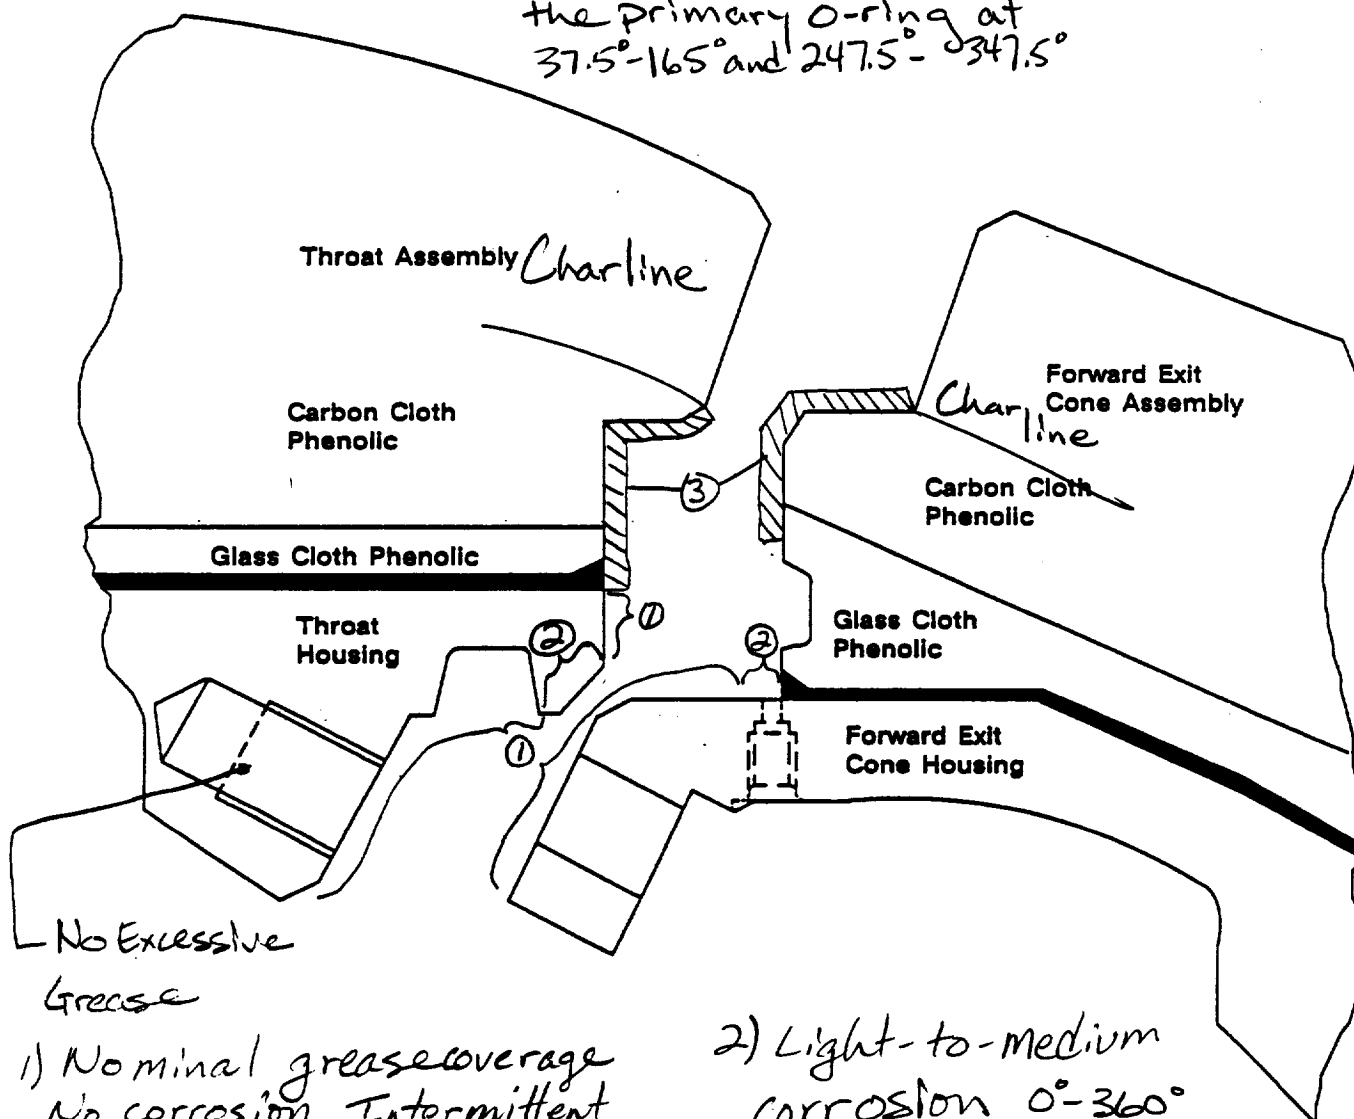
3) RTU reached below the Charline 0°-360°. Reached the primary O-ring at 37.5°-165° and 247.5°-347.5°

1) Nominal grease coverage
No corrosion. Intermittent drops of water.

2) Light-to-medium corrosion 0°-360° between the phenolics and secondary O-ring

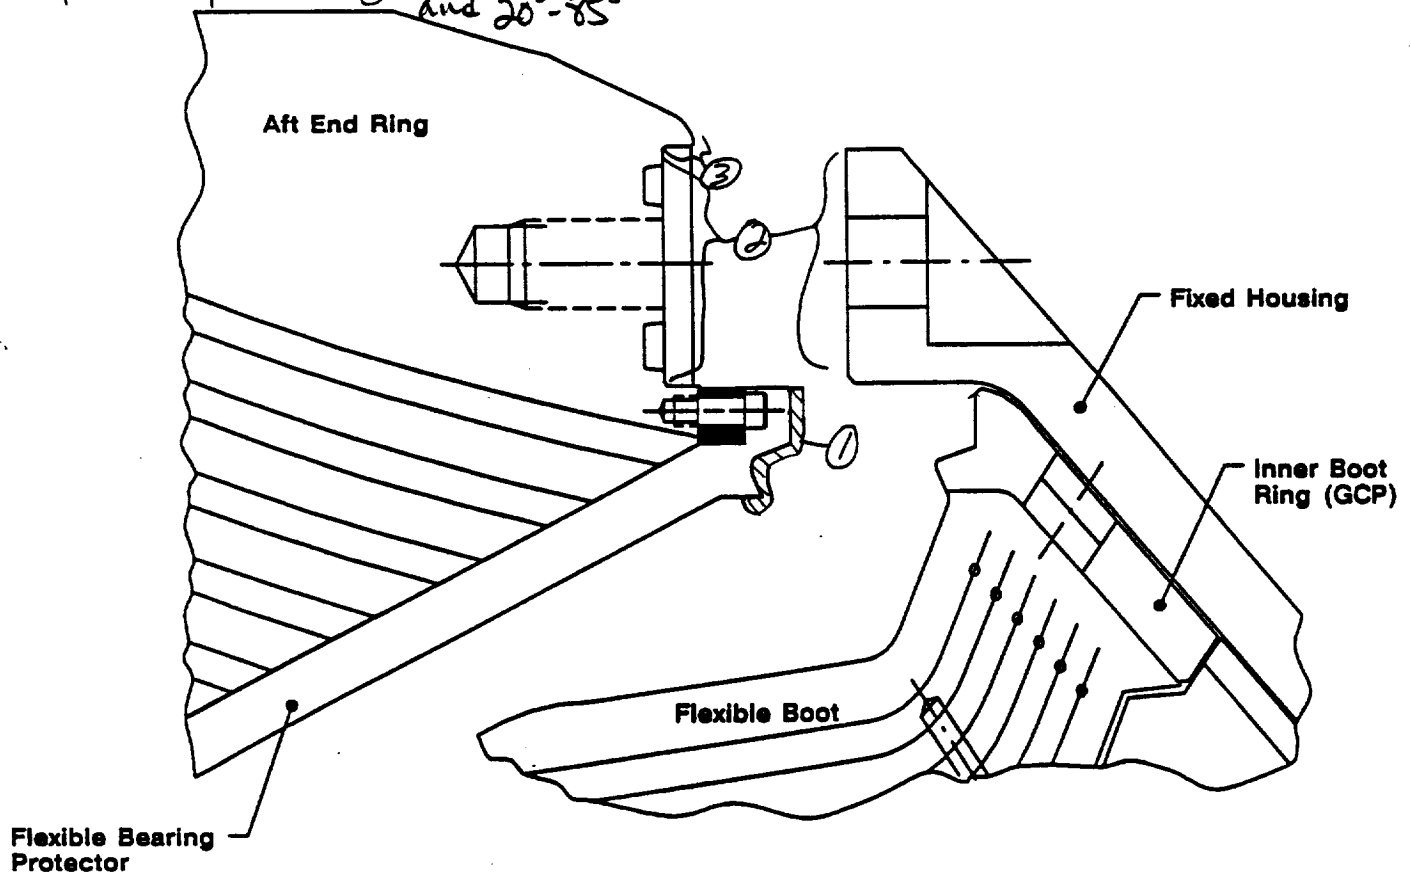
2) Nominal grease coverage with no corrosion

3) Intermittent medium corrosion 0°-360°

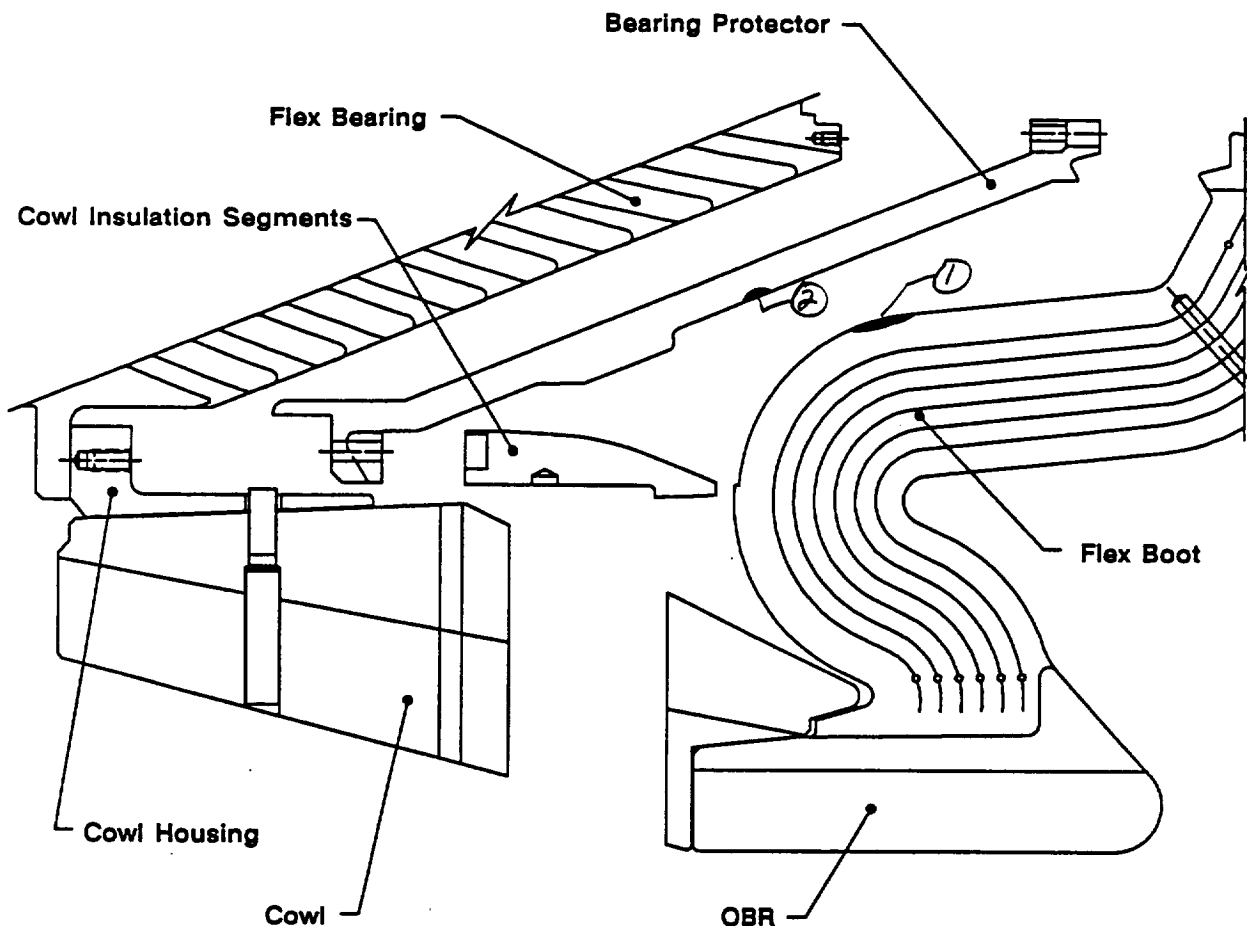
There was typical even sooting on the bearing protector and the flex boot ID. Erosion was observed on the bearing protector aft of the belly band at 150 and 178-to-185 degrees. Corresponding areas were also observed on the flex boot in the same locations. It appeared that slag was trapped between the boot and bearing protector. Slag was found in the boot cavity. (See Preliminary PFAR 53C-01.)

- 2) Erosion on bearing protector at:
- a) 150°, 1.8" aft of belly band
1.5" circ. x 1.1" axial
 - b) 178°-195°, 1.8" aft of belly band
5.4" circ. x 1.3" axial

- ① 180° 5.4" circ. x 1.1" axial
150° 1.7" circ. x 1.2" axial
Erosion on flex boot
Appears that slag was trapped between the boot and bearing protector

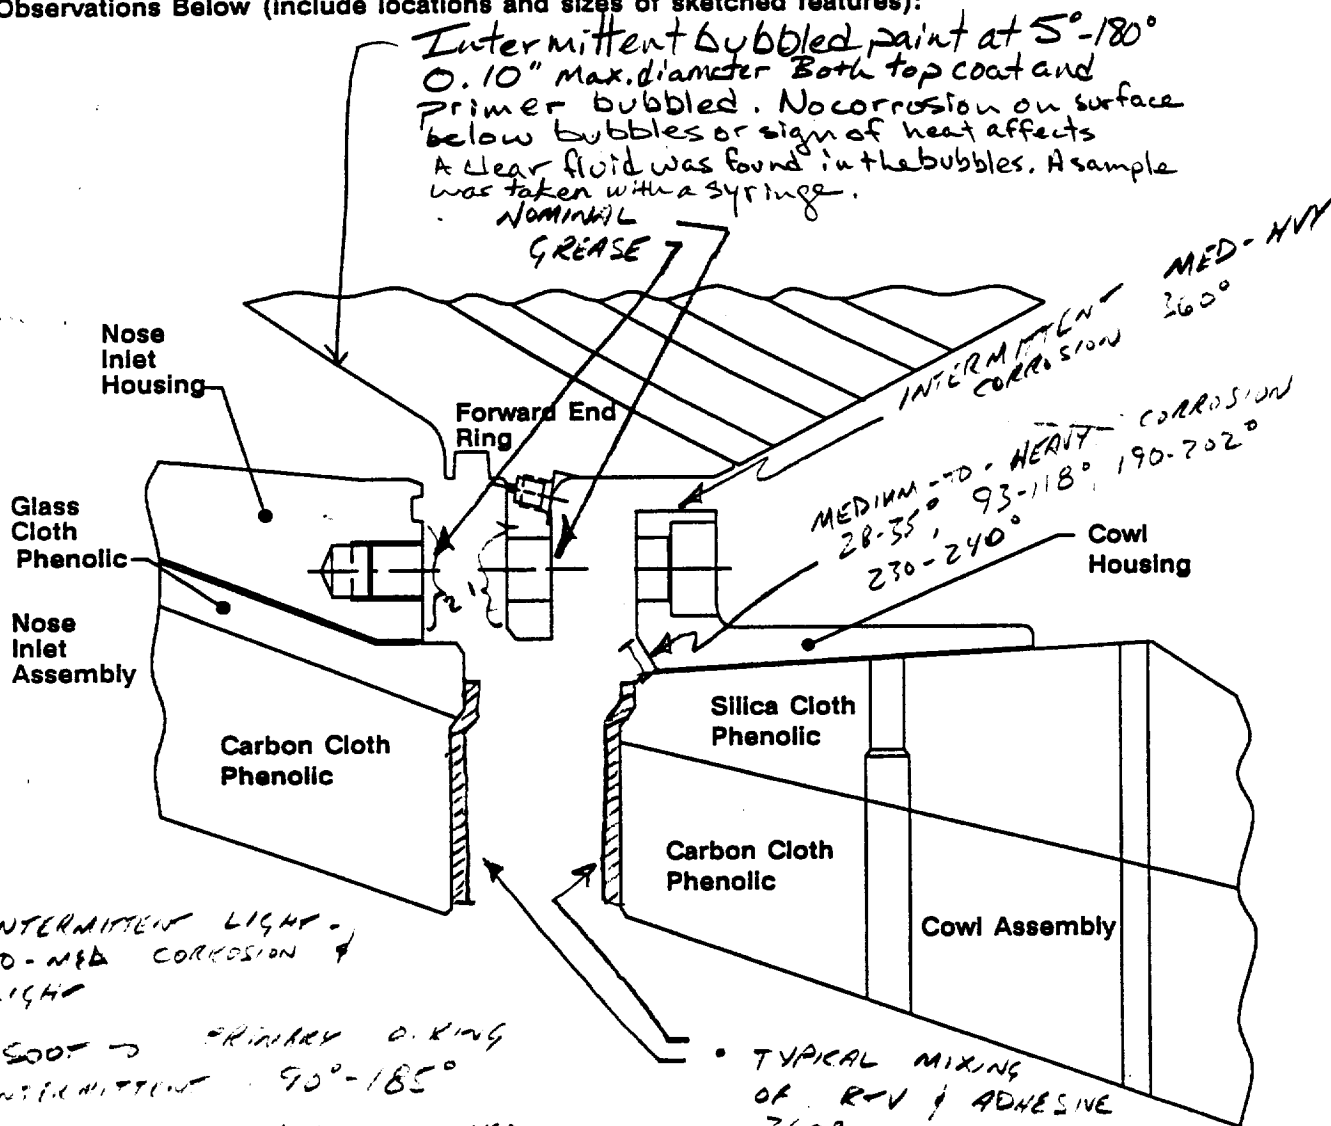
- 1) INTERMITTENT LIGHT-TO-MED CORROSION & LIGHT
- 2) SOOT - PRIMARY D.R. KING INTERMITTENT 90°-185°
- INTERMITTENT LIGHT-TO-MEDIUM CORROSION 360°

- TYPICAL MIXING OF R-V & ADHESIVE 360°
- HEAVY SOOTING 45°-210°
- LIGHT-TO-MEDIUM SOOTING 210°-0°-45°

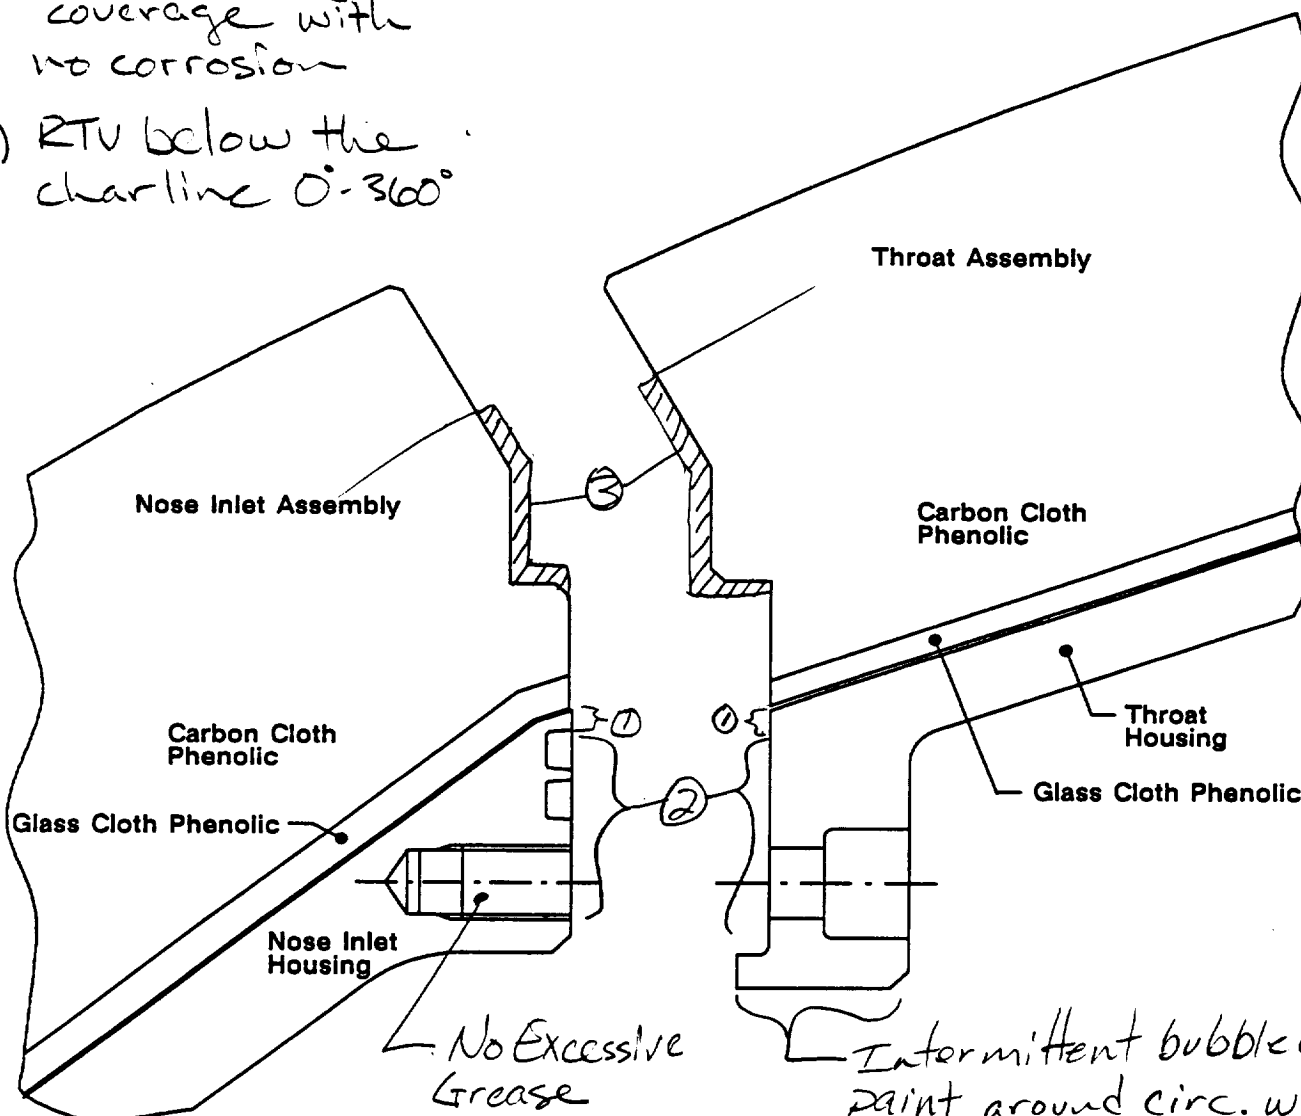
2) Nominal grease coverage with no corrosion

3) RTV below the char line $0-360^\circ$

Intermittent
1) Light-to-medium
corrosion around the
fire.

— Intermittent bubbled paint around circ. with a max. dia. of 0.05" No Fluid in bubbles, corrosion or sign of heat affects observed.

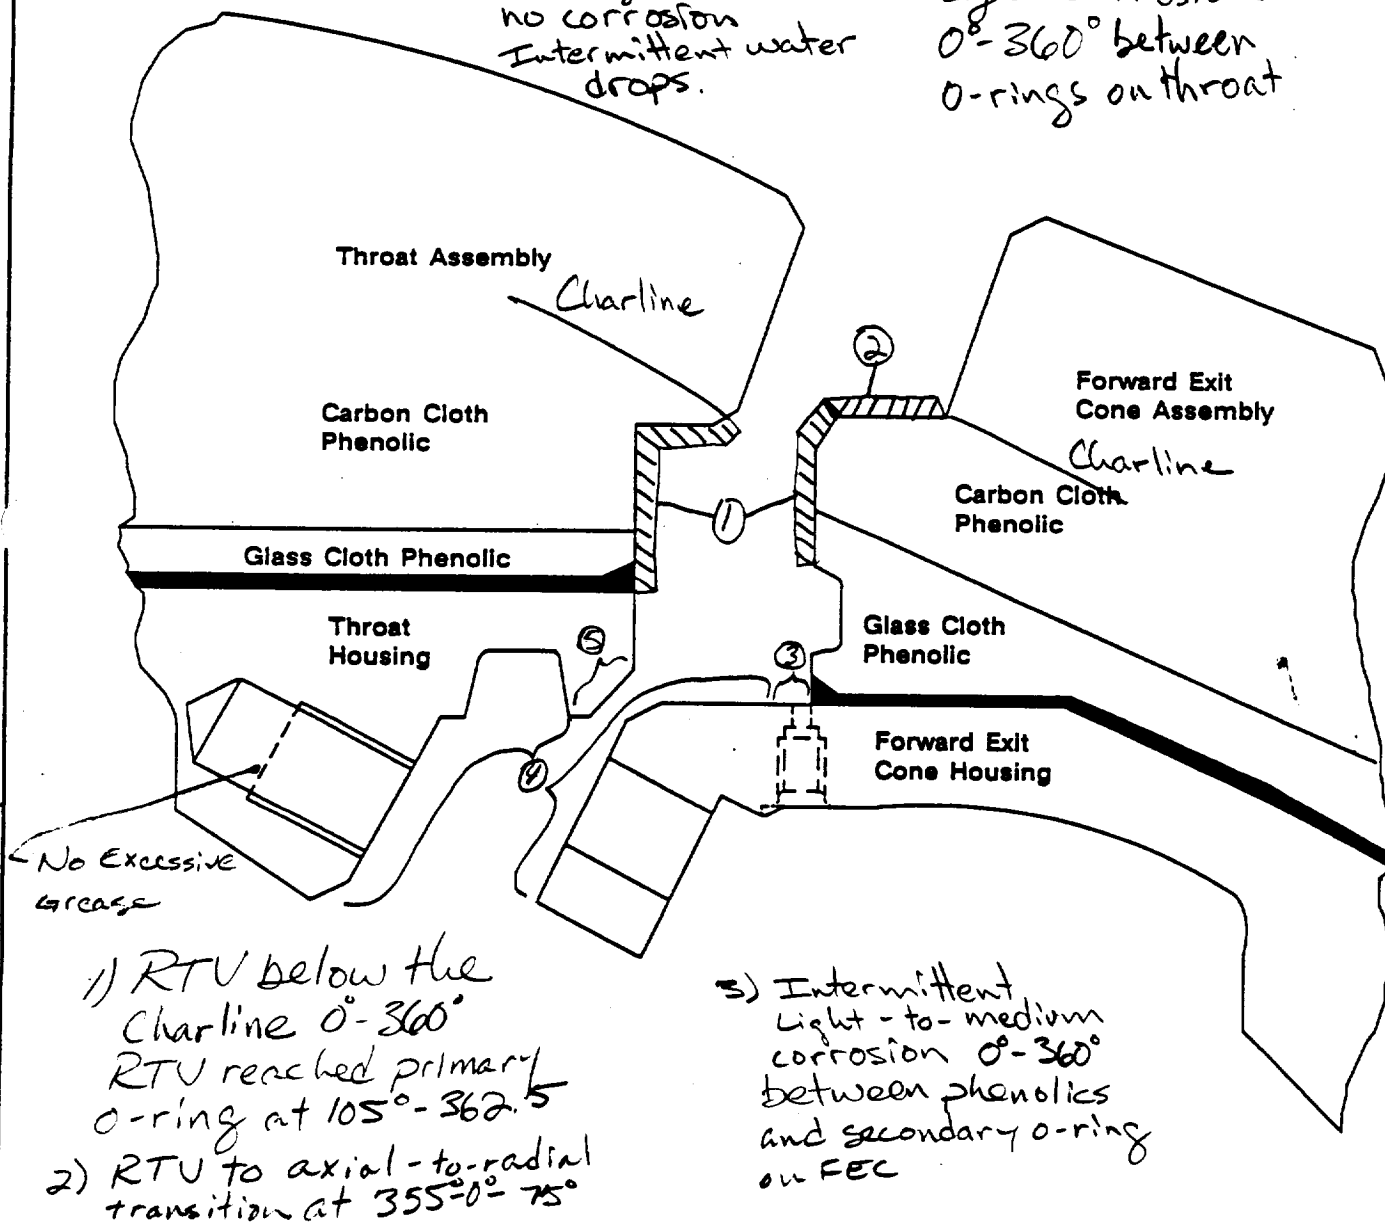
4) Nominal grease coverage with no corrosion
Intermittent water drops.

5) Intermittent light corrosion
0°-360° between O-rings on throat

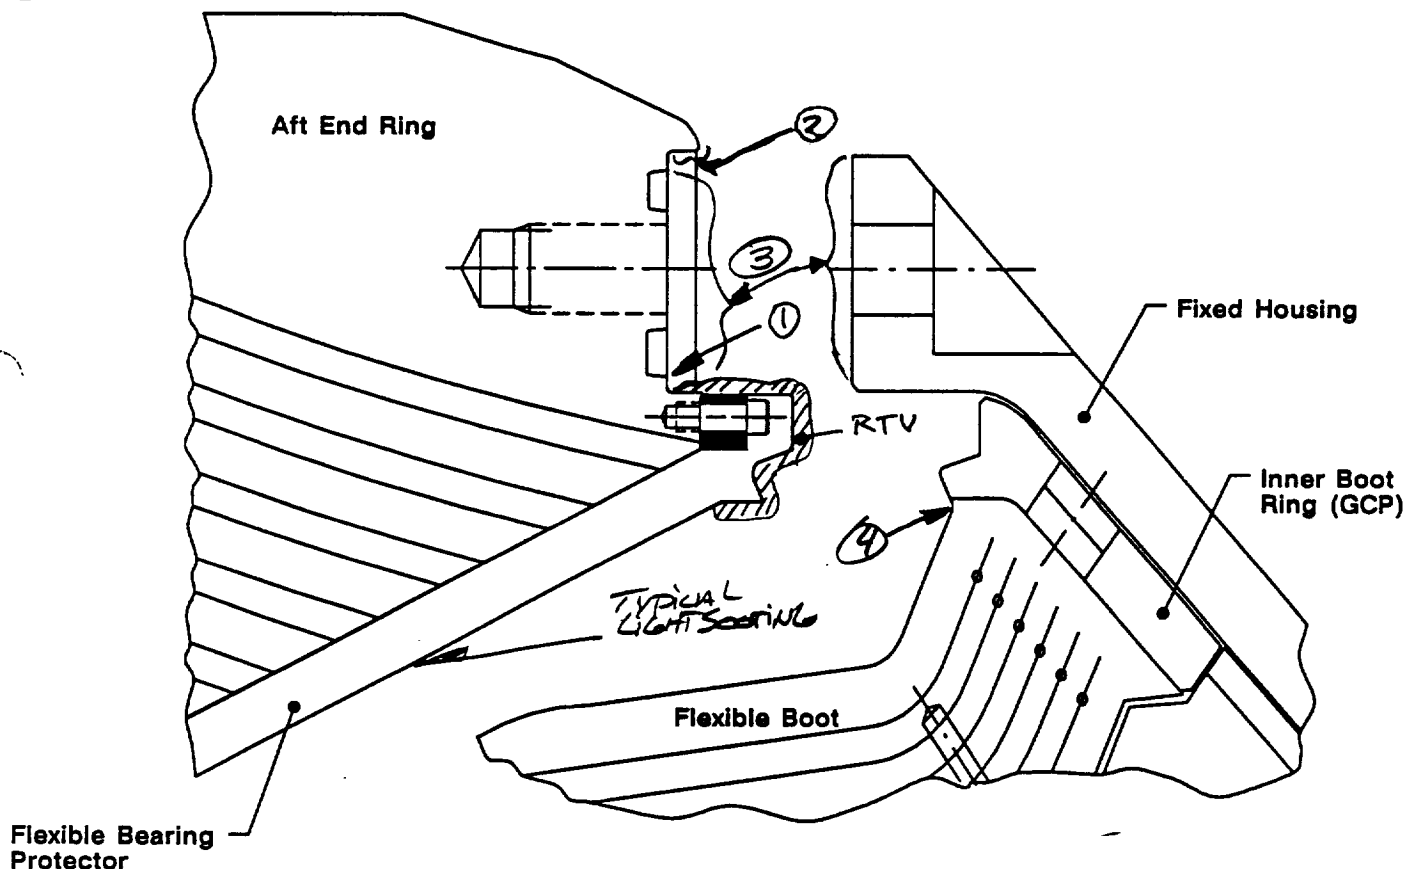
② MEDIUM CORROSION: INTERMITTENT.

④ Special Issue 3.3.1: NO EVIDENCE
OF ABNORMAL SEPARATION OR
SIGNS OF PROPAGATION

③ TYPICAL GREASE CONDITION
NO CORROSION.
